NASA TM X-1048

PRELIMINARY INVESTIGATION
OF EFFECT OF ENVIRONMENTAL
FACTORS ON SALT STRESS CORROSION
CRACKING OF Ti-8A1-1Mo-1V
AT ELEVATED TEMPERATURES

by David N. Braski

Langley Research Center

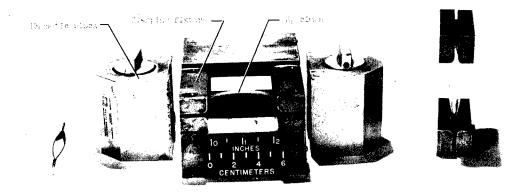
Figure 3.- Specimen, alinement fixtures, and clamping fixtures.

- (a) Specimen.
- (b) Alinement fixtures.
- L-64-7025.1 (c) Specimen with upper and lower clamping fixtures.

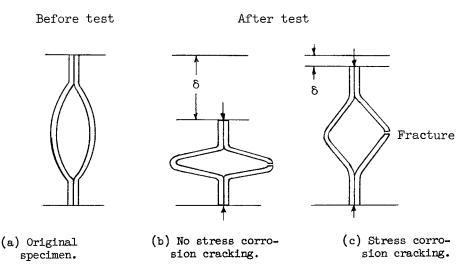
The effects of the various environments on the stress corrosion cracking in Ti-8Al-1Mo-1V were evaluated by the compression tests. Typical specimen configurations before and after compression testing are illustrated in figure 4. Specimens with no stress corrosion cracks could be compressed approximately 1.6 inches (4.1 cm) before fracture occurred at the bend (fig. 4(b)). Specimens with stress corrosion cracks fractured after relatively small amounts of shortening (fig. 4(c)). It was shown in reference 2 that the greater the maximum crack penetration, the smaller the amount of shortening needed to produce fracture. The following paragraphs are a discussion of the effects of different variables and environments on the stress corrosion cracking of Ti-8Al-1Mo-1V specimens stressed at 100 ksi (689 MN/m²). The results are shown graphically with specimen shortening at fracture, determined from the compression tests,

Figure 4.- Specimen configuration before and after roomtemperature compression test. δ represents shortening.

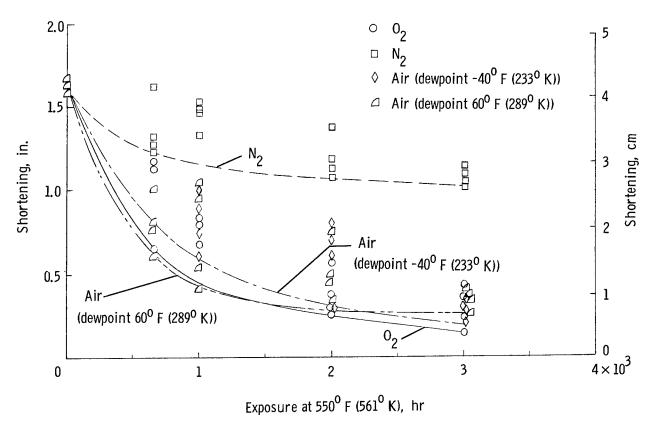
Figure 5 shows that specimens encapsulated in air with dewpoints of -40° F (233° K) and 60° F (289° K) displayed almost the same values of shortening with exposures up to 3000 hours. Therefore, moisture in this dewpoint range had little effect on stress corrosion cracking.

Figure 5.- Effect of oxygen, nitrogen, dry air, and moist air on shortening of Ti-8Al-1Mo-1V specimens after exposure at 550° F (561° K).

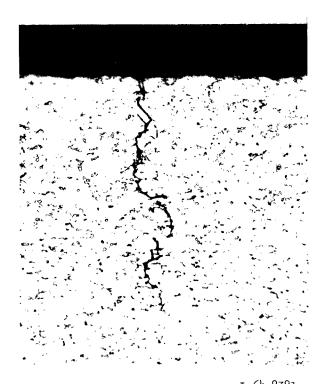
Moist chlorine gas was found to produce extremely severe stress corrosion in uncoated Ti-8Al-1Mo-1V at 550° F (561° K) (experiment 5 in table I). All of the specimens failed completely as a result of stress corrosion cracking before the 500-hour exposure time was reached. In every case, failure occurred at the intersection of the straight and bent portions of the specimens before removal from the oven. Figure 8 shows a photomicrograph of a stress corrosion failure area at one such intersection. Note the small intergranular cracks branching off of the main crack where failure occurred. The cracks were most numerous in

the vicinity of fracture and only a few were observed on the center portions of the specimen.

The specimens were covered with a dark purple corrosion product whose color and solubility properties in water are similar to those of TiCl3. Attempts to identify the products by X-ray diffraction failed as they were extremely hygroscopic. This experiment has shown that moist chlorine causes severe stress corrosion cracking, with a TiCl3 corrosion product, but it does not provide any clue as to the role of moisture in combination with chlorine.

Figure 8.- Edge view of stress corrosion cracks in fracture zone of Ti-8Al-1Mo-1V specimen exposed in moist chlorine for 500 hours at 550° F (561° K). ×150.

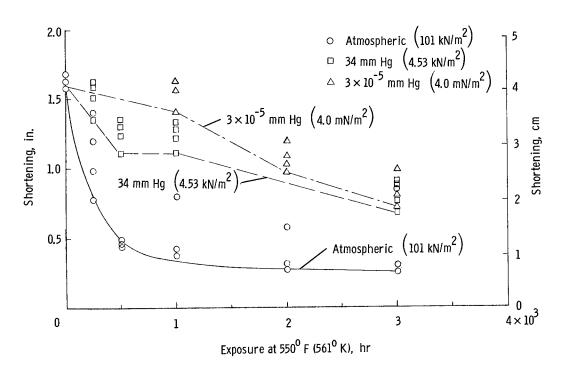
The effect of atmospheric $(101kN/m^2)$, 34 mm Hg $(4.53 kN/m^2)$, and 3×10^{-5} (4.0 mN/m²) pressure on the salt stress corrosion cracking of Ti-8Al-1Mo-1V (experiments 6, 7, and 8in table I) is shown in figure 9. pressure of 34 mm Hg simulates the static pressure at an altitude of 70,000 feet (about 21,000 m), the approximate cruising altitude for a supersonic transport. Note that, as the pressure is reduced, the damage due to stress corrosion cracking is also reduced. This result generally agrees with tests reported in reference 8 on Ti-5Al-2.5Sn at various reduced pressures down to 1 micron (133 mN/m^2) exposed at 800° F (700° K) for 1 hour. The reduction of stress corrosion cracking with lower pressure can be explained by the decreased amounts of oxygen available to the reaction.

Figure 9.- Effect of pressure on shortening of salt-coated Ti-8Al-lMo-lV specimens after exposure at 550° F (561° K).

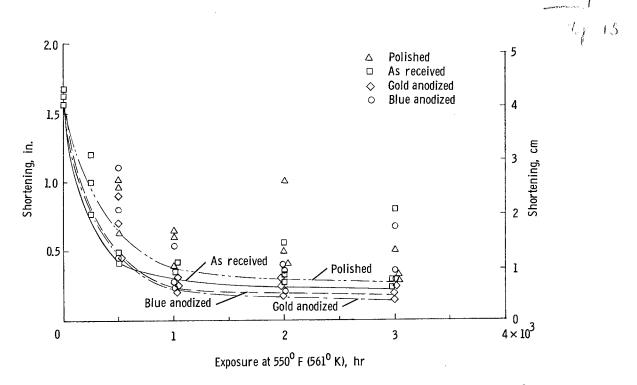
The results in figure 10 indicate that oxide films less than 600 angstroms do not noticeably affect stress corrosion cracking in Ti-8Al-1Mo-1V under the experimental conditions. However, data in reference 7 showed that a thicker gray oxide film (estimated from ref. 5 to be greater than 1000 Å) offered some protection against salt stress corrosion in Ti-6Al-4V exposed at 750° F (672° K) and 800° F (700° K) up to 50 hours.

Figure 10.- Effect of different surface conditions on shortening of salt-coated Ti-8Al-lMo-lV specimens after exposure at 550° F (561° K) in air.

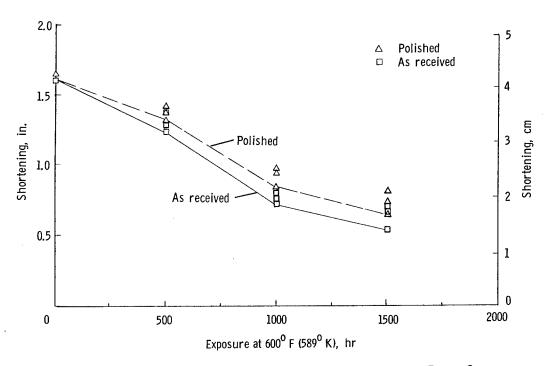
Figure 11.- Effect of surface condition at 3×10^{-5} mm Hg (4.0 \times 10⁻³ mN/m²) on shortening of salt-coated TI-8Al-1Mo-1V specimens after exposure at 600° F (589° K).

As a further check on the effect of surface conditions, salt-coated specimens with polished and as-received surfaces were encapsulated separately under a pressure of 3×10^{-5} mm Hg (4.0 mN/m²) (experiments 12 and 13 in table I). Each capsule was heated to 600° F (589° K) while pumping down to insure the removal of moisture. The results in figure 11 indicate that polished specimens demonstrated slightly better resistance to stress corrosion cracking than did the as-received specimens. However, because of the limited number of specimens tested, it was difficult to draw any definite conclusions as to the relative effects of these two surface conditions. These tests do show that very little gaseous oxygen or surface oxide is necessary to produce stress corrosion cracks in Ti-8Al-1Mo-1V at 600° F (589° K).

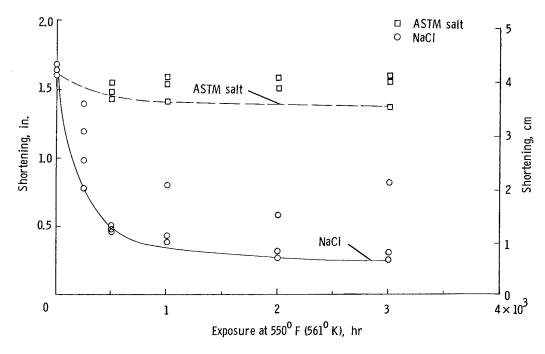
Figure 12.- Effect of salt composition on shortening of Ti-8Al-1Mo-1V specimens after exposure at 550° F (561° K).

The results for specimens with NaCl and ASTM salt coatings (experiments 6 and 14 in table I) are given in figure 12. For exposures up to 3000 hours at 550° F (561° K), the ASTM salt produced substantially less stress corrosion damage than the NaCl. This result was surprising since data from several investigations, such as reference 1, indicated that the effect of ASTM salt is probably more severe than that of NaCl. There seems to be no obvious explanation for this apparent inconsistency at this time. Additional stress corrosion tests are underway to determine the relative effects of NaCl, ASTM salt, and natural sea salt.
